# Blending restorations into natural dentition following a trauma incident

Dr Alex Lindfield BDS (Hons), MFDS RCPS (Glas) and Mr Paul Gerrard Clinical Dental Technician, CDT Dip RCS (Eng)

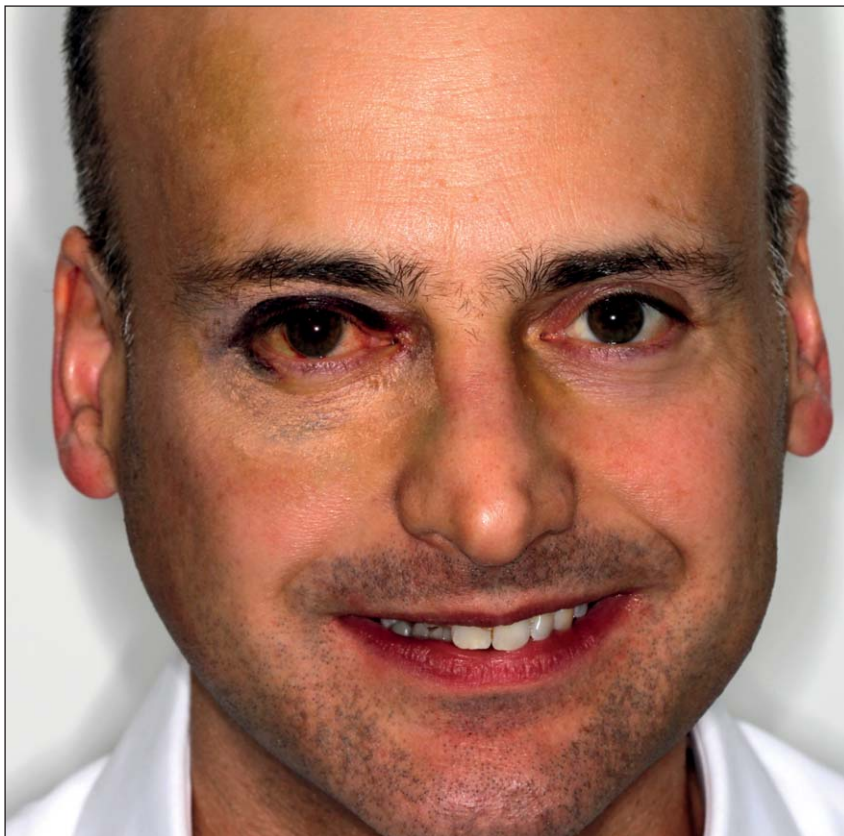
Figure 1

A 35-year-old male attended the practice as an emergency new patient in November 2015 with two damaged front teeth following facial trauma the night before. He complained that his damaged teeth were sensitive to cold drinks and the air and wanted to know what could be done to restore them back to their original appearance. While

the teeth were sensitive, they were not causing him any pain and he was managing by avoiding eating and drinking on the affected side (*Figure 1*).

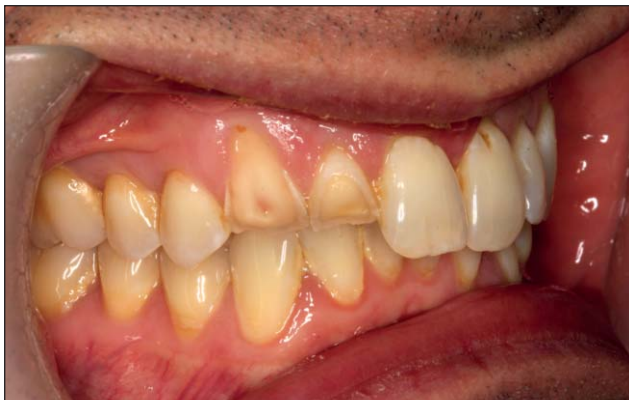
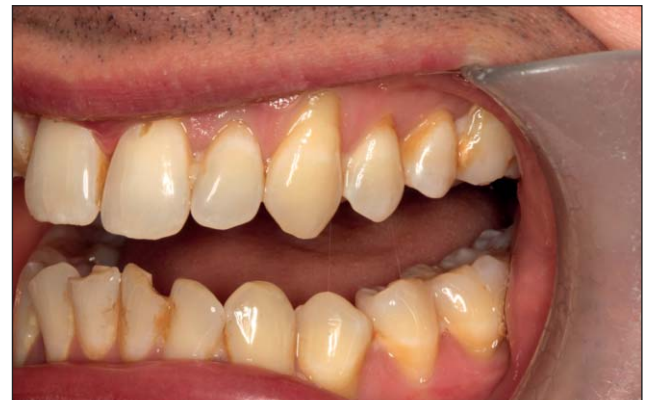
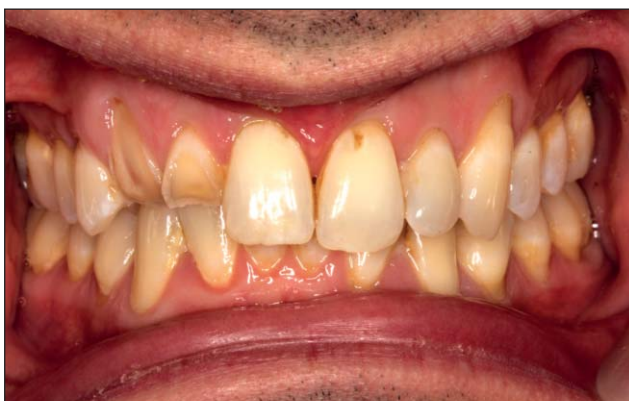
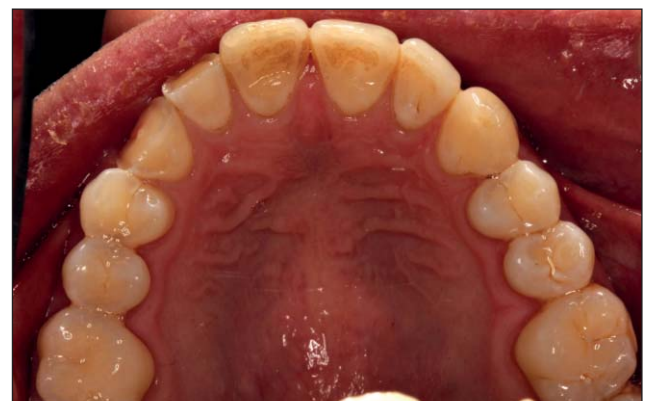
fractured lower teeth treated with his own dentist, and therefore only an intra-oral periapical radiograph of the fractured upper right lateral and canine teeth were taken. It was made clear to the patient that ideally a similar radiograph should be taken to assess for root fractures on the lower front teeth and possibly an OPT to assess for condylar and coronoid fractures. Only the upper right lateral and canine were sensitive to cold, and no teeth were tender to percussion or mobile. Pre-operative photographs were taken (Figures 2-6).

- Complicated enamo-dentine crown fracture of the upper right canine
- Non-complicated enamo-dentine crown fracture of the upper right lateral incisor
- Non-complicated enamo-dentine crown fracture of both lower central incisors
- Caries on the lower right first molar
- Generalised gingival recession due to a thin gingival biotype and possible overzealous brushing.

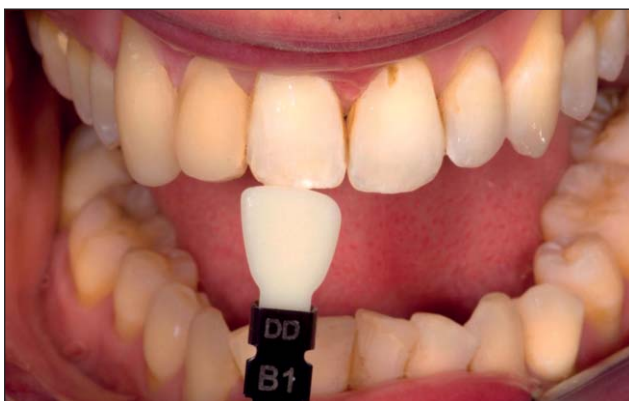
- 5) Shade taking involved a sequence of photographs being taken alongside my in-practice technician with a number of shade tabs from numerous angles. Cross-polarised images were taken as they block out unwanted light and help identify internal effects and opacity.<sup>5</sup> My technician was able to use these images and change the contrast on Photoshop to further identify underlying features of the teeth and construct an accurate shade map (Figures 9, 10)

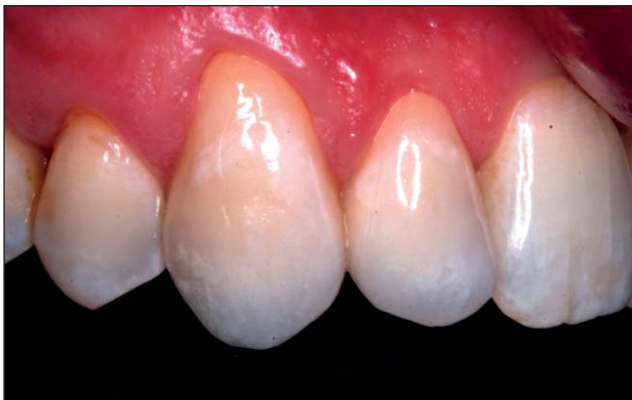
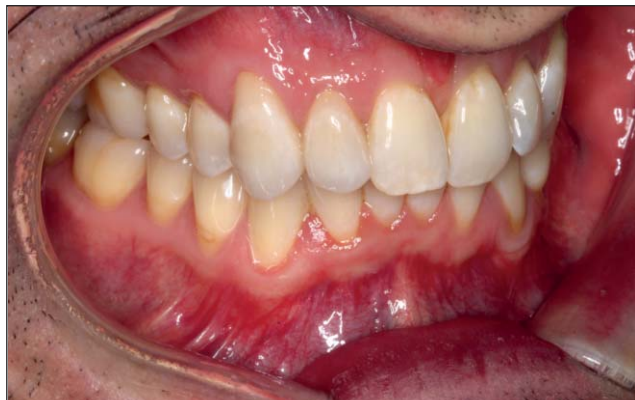
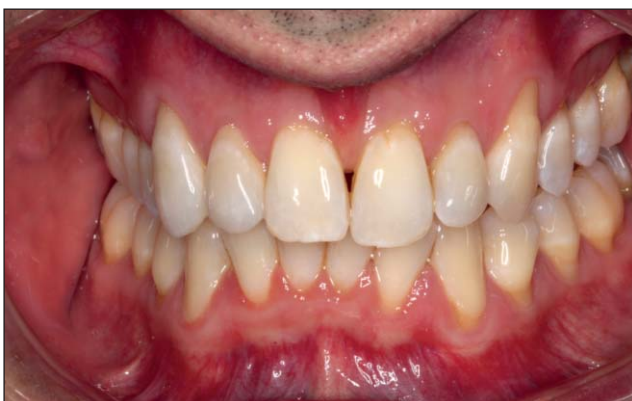
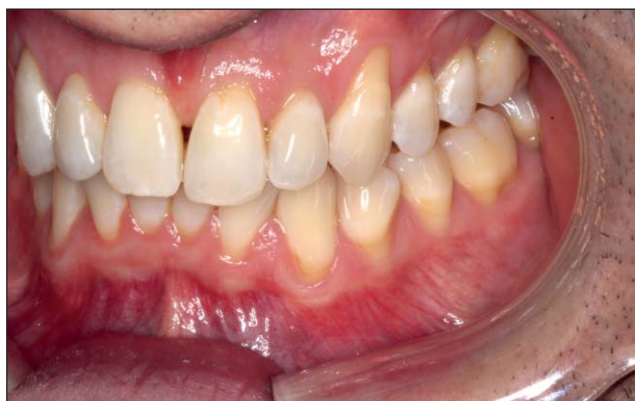
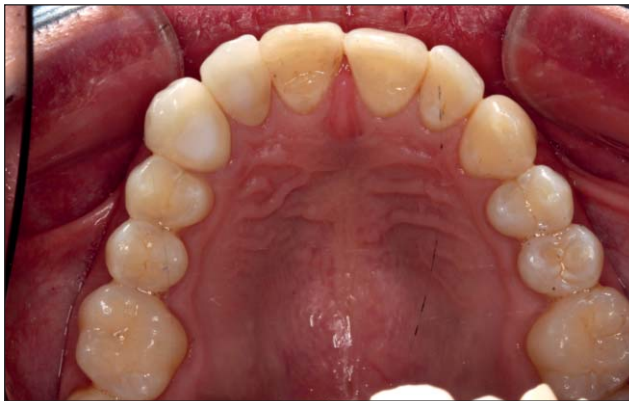
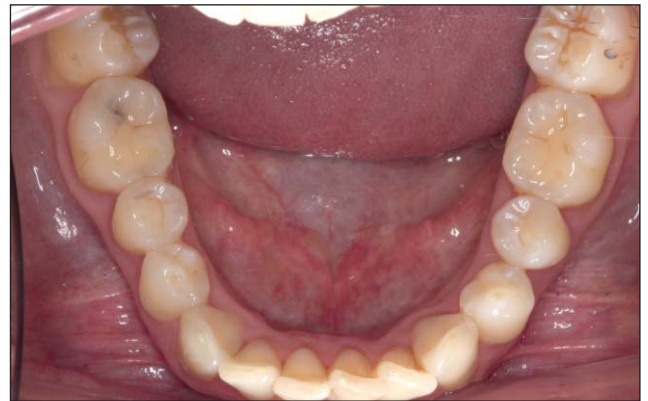
An excellent restorative result was achieved and it is satisfying that the patient was so pleased with his new smile. It was great to be able to provide an aesthetic and natural

- 6) Both crowns were constructed using a B1 Emax core and then layered labially with a sequence of Emax tints and shades, involving three firings (Figures 11, 12)
- 7) The crowns were tried in with try-in paste to allow the patient and dentist to assess the aesthetics. All parties confirmed they were happy with the colour and shape and the contacts were all correct. The teeth were then cleaned and prepared for cementation using air abrasion<sup>6</sup> and the crowns were cemented in place with

RelyXunicem. All excess cement was removed and the occlusion was refined to allow for lateral and protrusive movements while maintaining canine guidance (Figures 13-20).

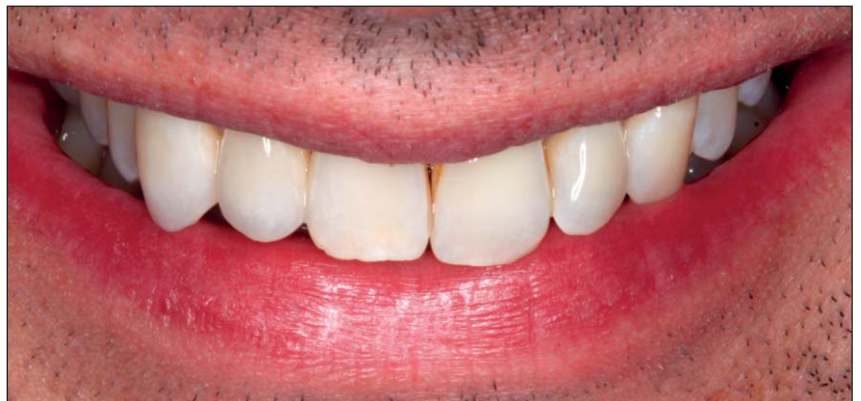
Figure 20

photography that enabled extremely effective communication with a talented ceramist resulting in an accurate and aesthetically natural shade and appearance match. I had warned the patient that multiple try-ins might be required to match the shade and features to the adjacent teeth, however we were able to get the crowns right first time. Had the patient not lived so far away I might have considered a few trial fits before the different firings to avoid the risk of multiple corrections. I think the cross-polarised images helped better assess the underlying dentine shade, and also helped show the white marks, striations and other internal features in the adjacent teeth. This photographic technique is definitely something I intend to do more of when matching restorations to adjacent natural teeth.
