Minimally Invasive elimination of white spots

Dr Richard Field BDS Hons (Glas)

Treatment

- Resin infiltration (DMG Icon) upper laterals
- Combined resin infiltration and direct composite upper centrals

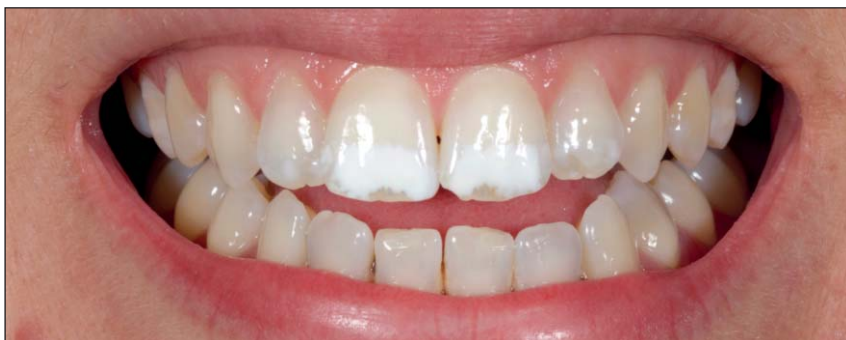
Figure 1

A 27-year-old female presented requesting an improvement to her smile with reference to the white discolouration to her upper front teeth (*Figures 1, 2*)

- Unremarkable
- Extra-oral: NAD, TMJ non clicking, no pain on loading or palpation.
- Intra-oral:
 - Good general dental health
 - Moderate fluorosis affecting the upper incisors
 - The fluorosis was markedly worse on the upper centrals where there was a marked white opacity
 - Molar-incisal hypoplasia was ruled out due to absence of

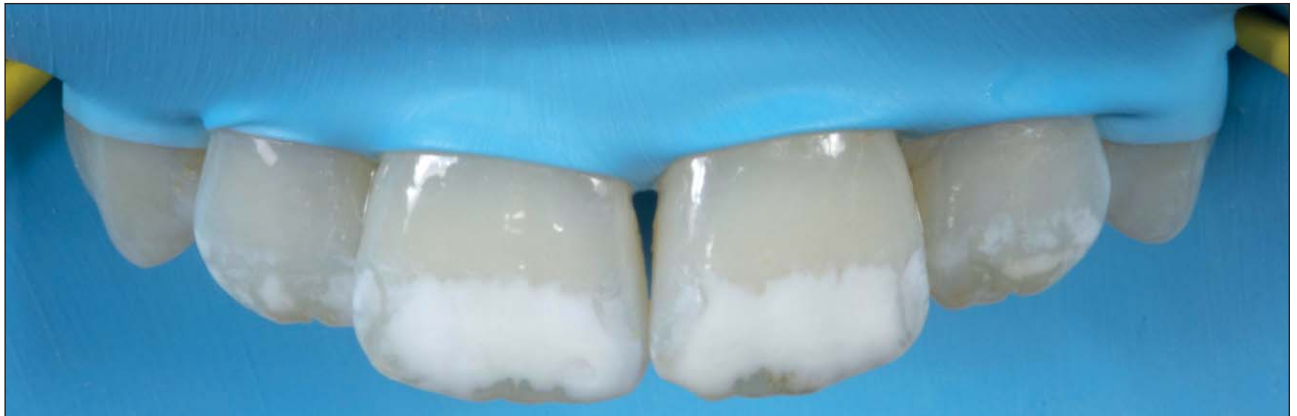
Figure 3

As Icon treatment requires working with a strong acid, it is important to isolate the soft tissue from the area you will be working on. Isolation was achieved from upper first molar to upper first molar with a heavy gauge non latex dental dam (Unodent) with wedgits distal to the canines as this negates the need for local anaesthetic (*Figure 3*).

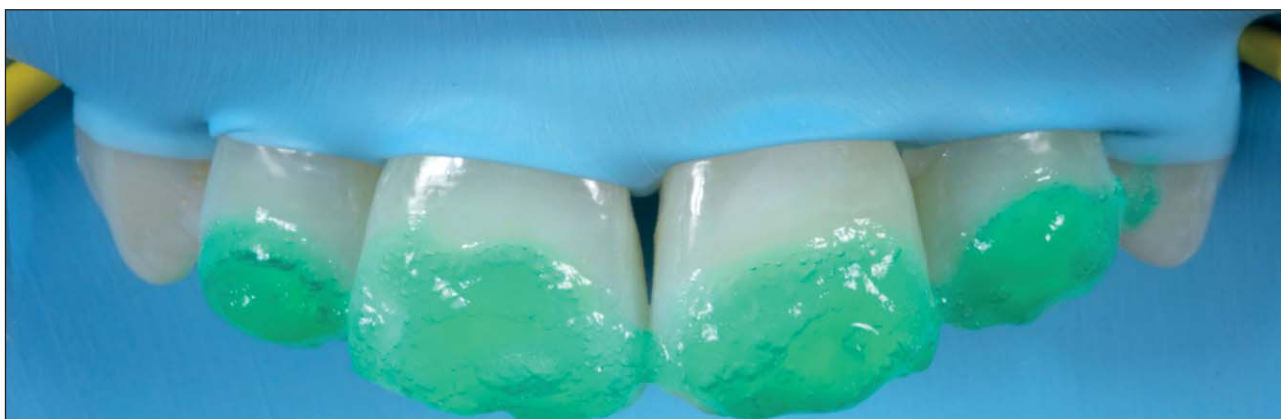
Figure 4

The areas to be treated were coated with Icon-Etch which is a 15% Hydrochloric Acid Gel, for two minutes before being washed off to leave the typical post acid etch frosted appearance (*Figures 4,5*). Following rinsing and drying, the lesions were then 'previewed' using the Icon-Dry ethanol solution provided (*Figure 6*). Icon-Dry has a

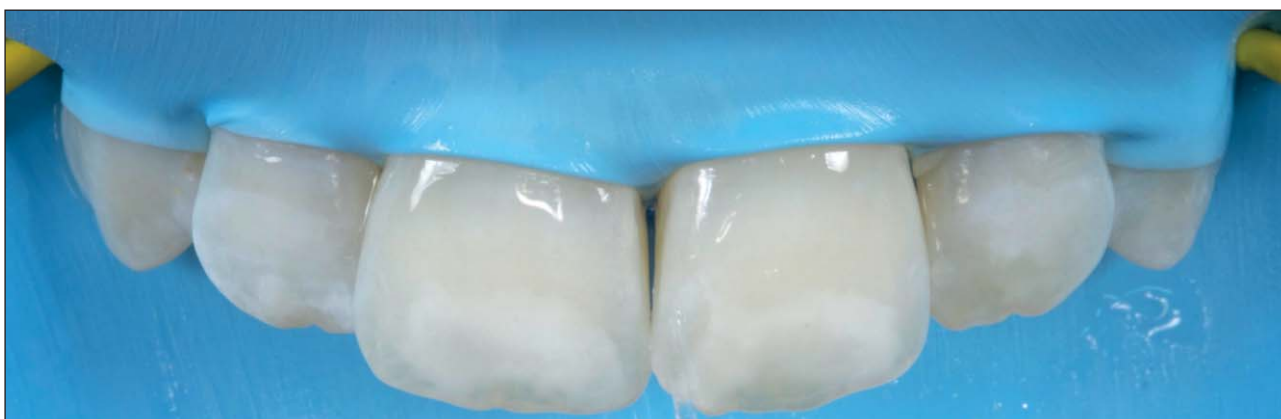
Figure 6

Initially, the process of etch, rinse and application of icon dry was carried out three times with no resolution of the white lesions on the centrals (*Figure 6*). This was

discussed with the patient and permission was granted to remove a thin layer of superficial enamel in order to access the white lesion to depth. A red band rugby ball bur was used to remove approx. 0.2-0.3mm of superficial enamel (Figure 7). The process of etch, rinse, and application of Icon-Dry was repeated two more times (Figure 8) until the majority of the white lesions were no longer visible following preview

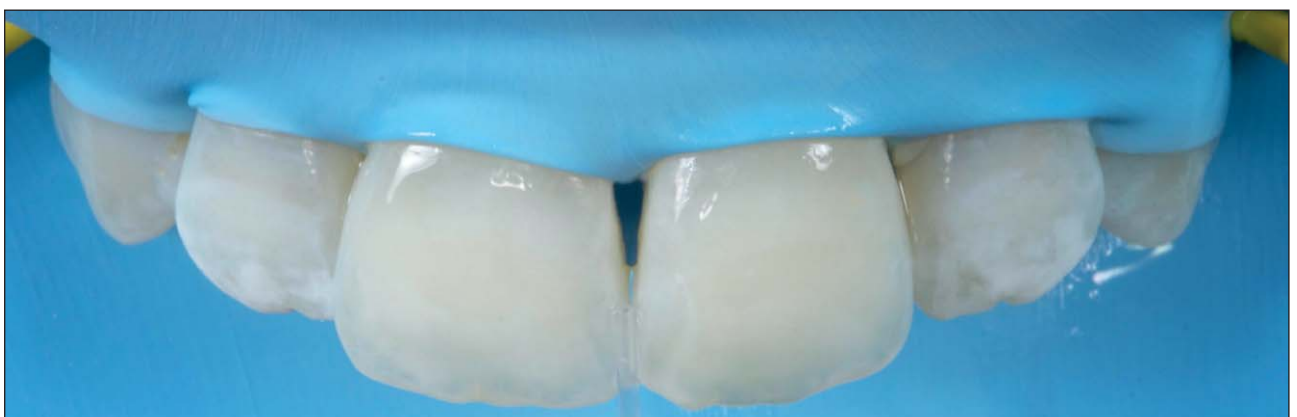
Figure 9

with the Icon-Dry ethanol solution (Figure 9).

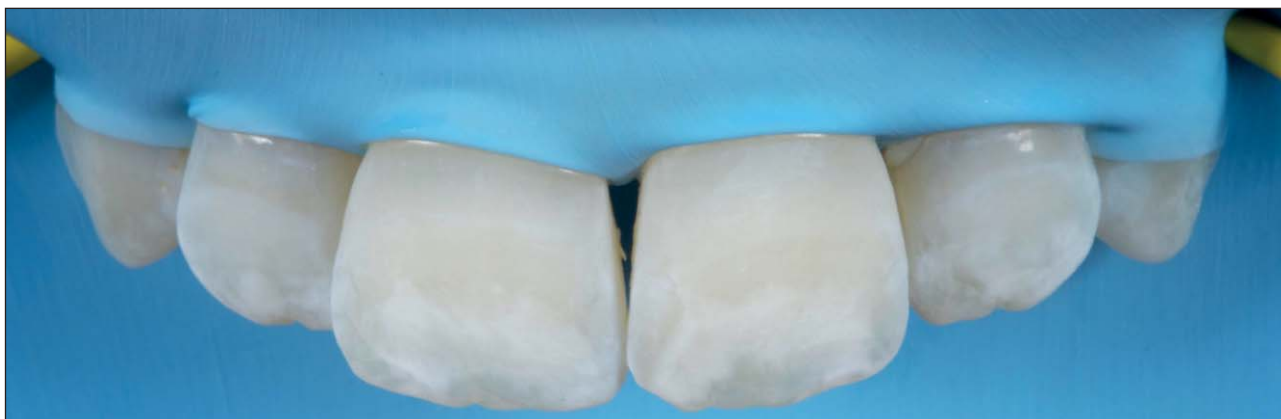
Figure 10

Once satisfied with the preview stage, the teeth are dried to a frosty post-etch appearance with a further application of the Icon-Dry ethanol solution being allowed to evaporate over 60s (Figure 10). The operating light was then switched off to prevent premature curing of the Icon resin and the hydrophobic Icon resin was

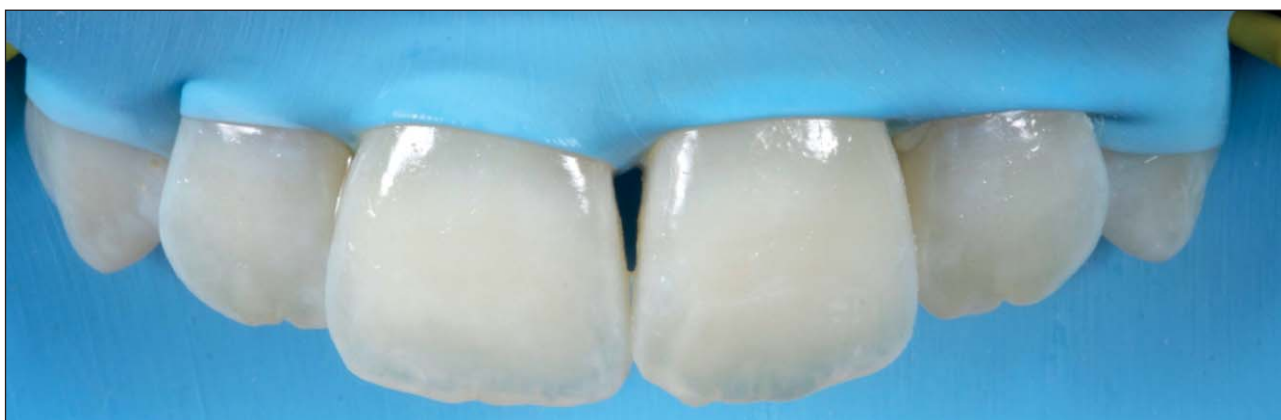
Figure 11

rough due to excess resin being present on the surface of the teeth (Figure 11). The defect caused by the removal of superficial enamel is also still present. According to the literature it is possible to bond to freshly cured icon resin without further conditioning as it exhibits its own oxygen inhibition layer.³ In the author's experience, there is sometimes a problem with delamination around the margins of

A thin layer of FL bottle 2 (Kerr) was painted over the defects and cured before the addition of a thin layer of achromatic composite (3MESPE,

Filtek Supreme XTE White enamel) which was cured for 40s before being cured again for a further 40s under a glycerine barrier. This final cure under the glycerine barrier serves to remove the sticky oxygen inhibition layer that can clog finishing and polishing instruments making them less effective⁴ (Figures 12,13). The teeth were polished with the Astropol (Ivoclar Vivadent) system until the surface of the composite

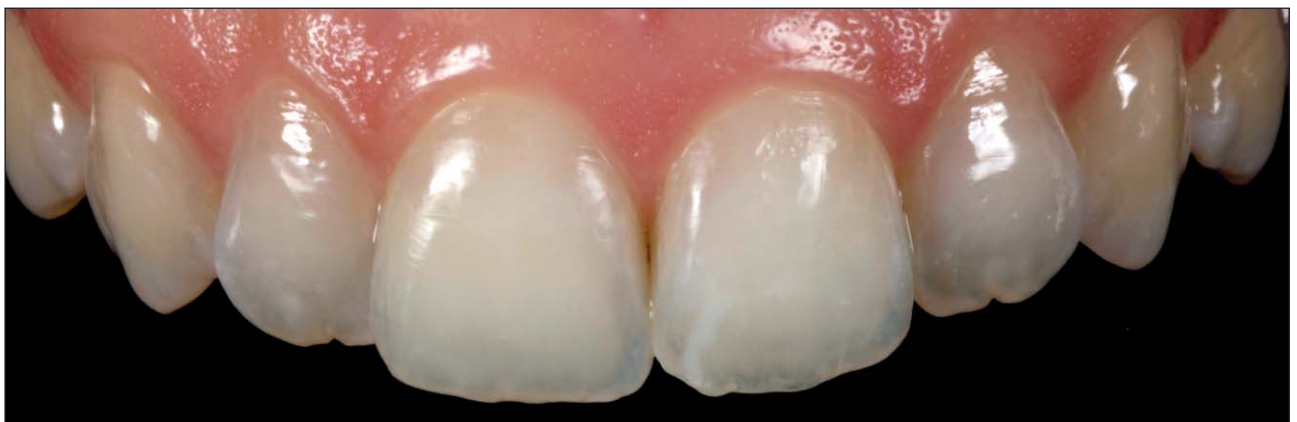
Figure 14

The patient was reviewed one month later and final review photos were

taken (Figures 14,15). The patient was thrilled with the huge improvement that the treatment had made to her smile. This was particularly significant as she had previously been told that nothing could be done and had reluctantly accepted that she may need veneers at some stage. She was so happy that she was able to get the result
