Replacement of unsightly amalgams: direct or indirect?

Accreditation Case Type 4

(A posterior quadrant showing two or more direct or indirect restorations)

Oliver Harman BDS, LDS RCS

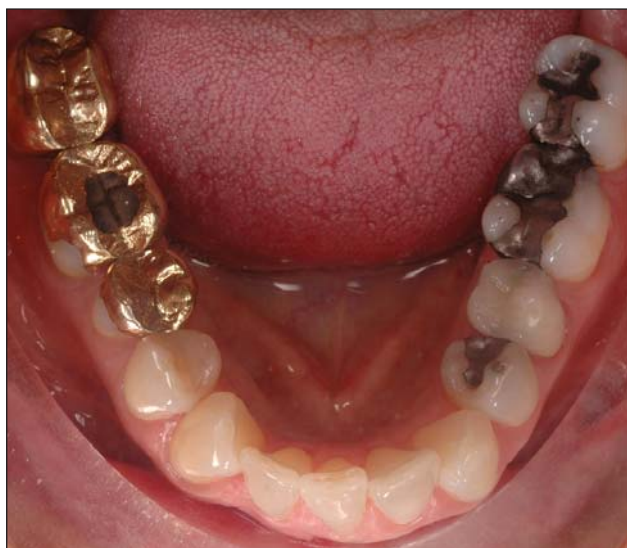
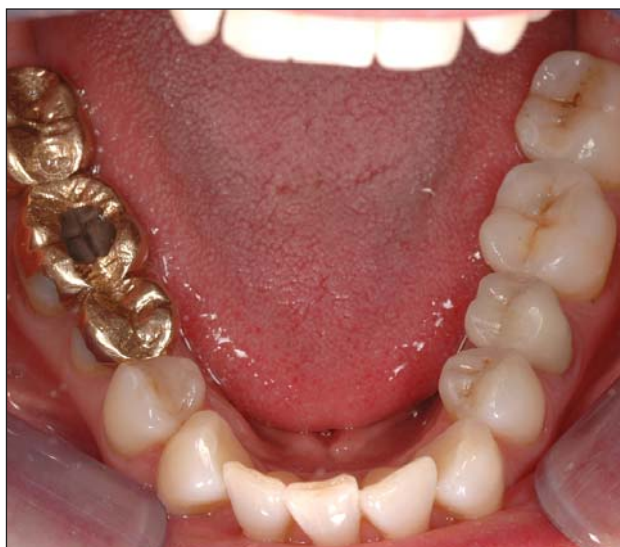
Figure 1: a-b – Occlusal images of the case: *Before (left) and after (right)*

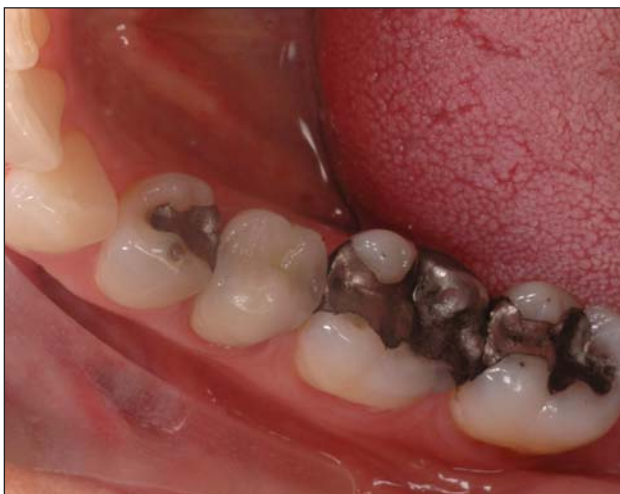
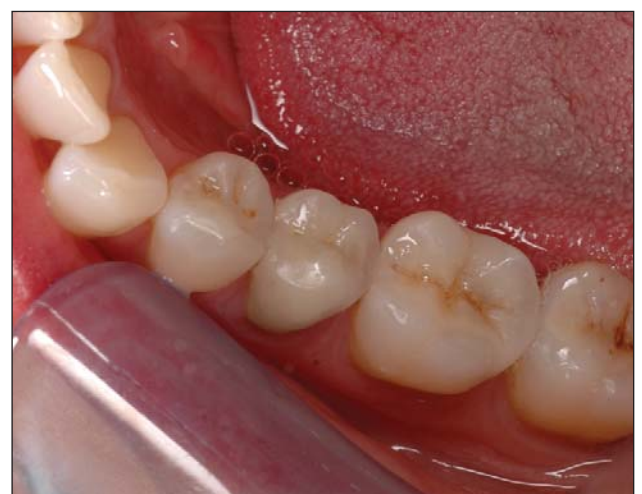
Figure 2: Lower Left Quadrant: Before (left) and after (right) images of the case

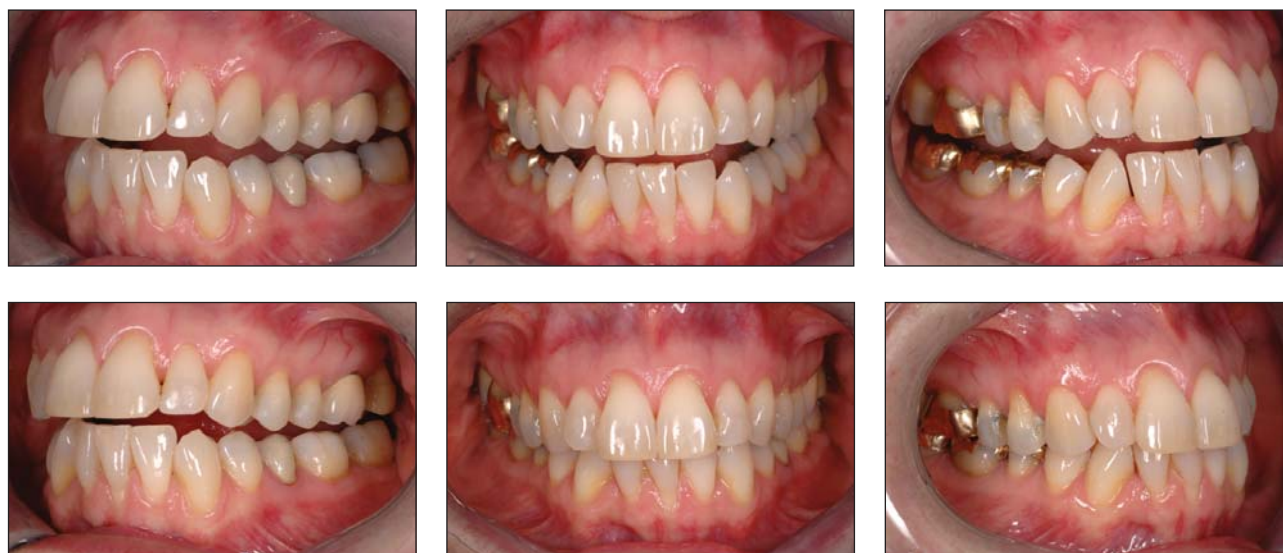
Figure 3: a-f – Retracted: *Before (above) and after (below) images of the case*

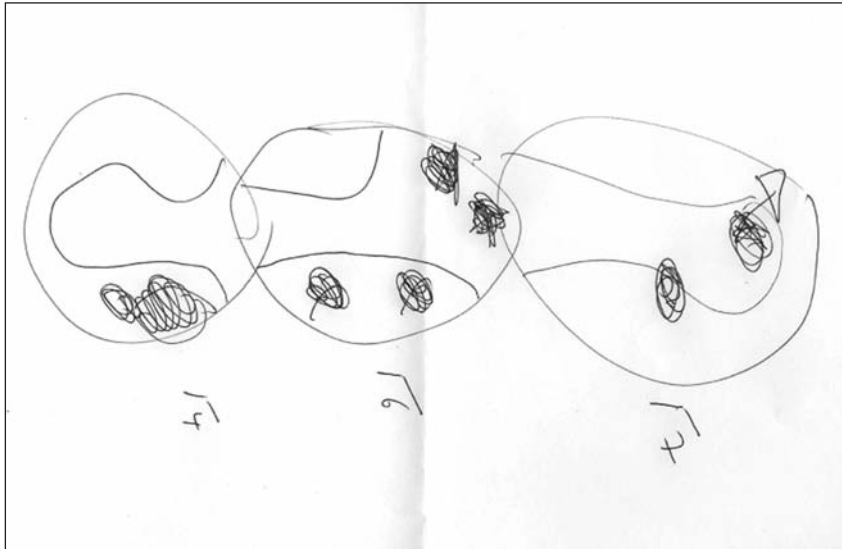
Figure 4: Bite Border

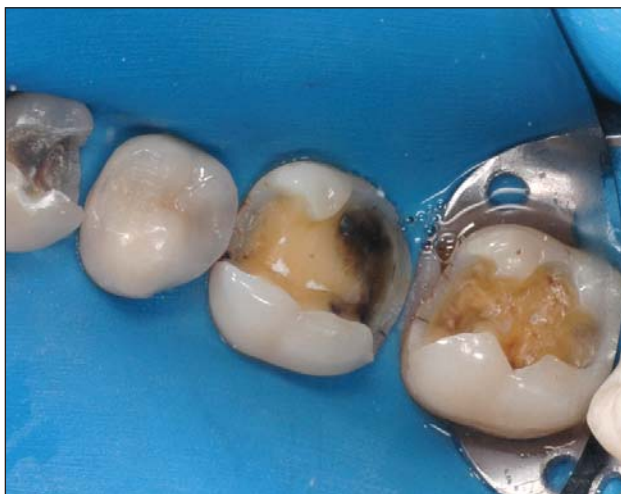
Figure 5: Preps under rubber dam

cavity reshaped using pear shaped diamonds, with copious amounts of cooling water to keep mercury vapour to a minimum. The undercuts on the 36 were removed with a tapered, round ended diamond. The tooth was carefully cleaned with fine diamonds, green abrasive stones and pumice to remove any stains and remnants of amalgam. The exposed dentine was temporarily covered with non-eugenol temp bond to avoid desiccation while the 34 and 37 were restored.

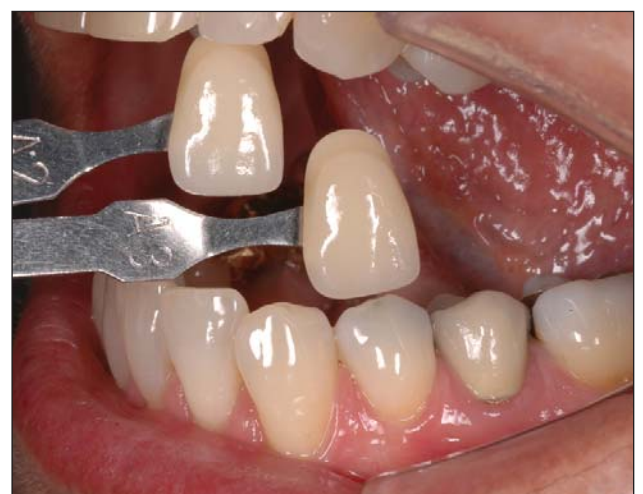
Figure 6: Shade Selection Vita A2 A3 Tab

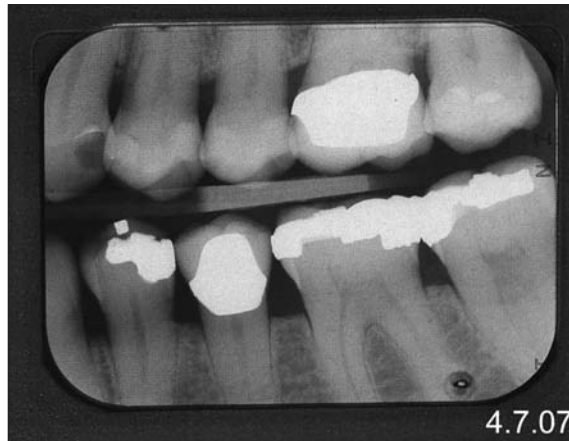
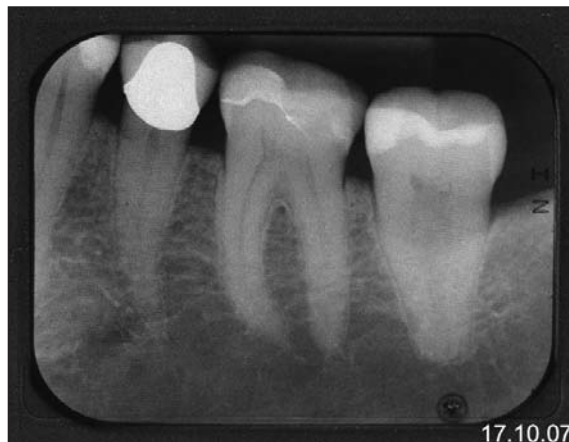
Figure 7: Post op PA LLQ: before (above) and after (below)
