Treating a discoloured tooth to match an otherwise unrestored dentition

Accreditation Case Type 2

(One or two indirect upper anterior restorations with natural teeth beside)

Elaine Halley BDS, DGDGP (UK)

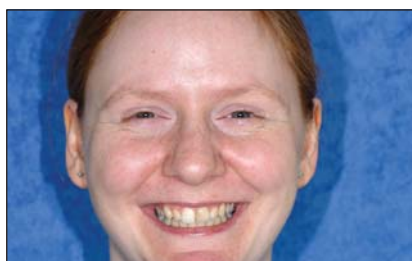
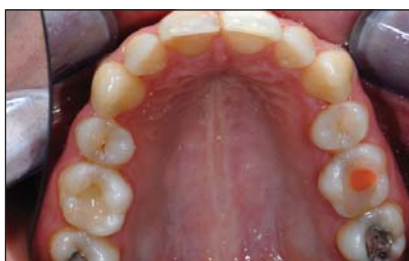
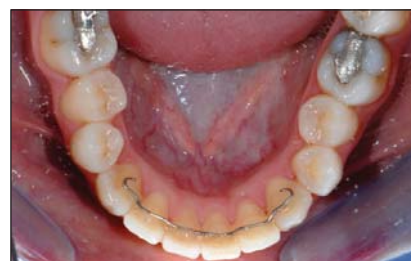
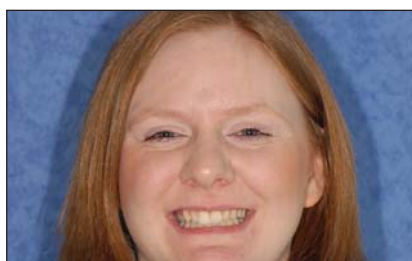
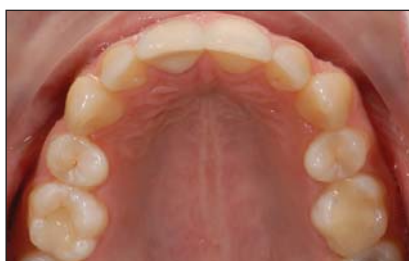
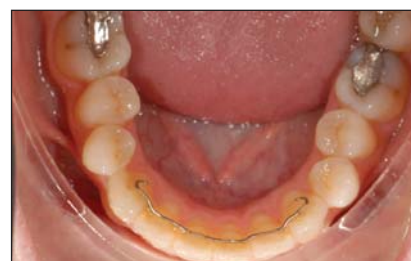
Figure 1: a-f – Full face, upper occlusal and lower occlusal: Before (above) and after (below) images of the case

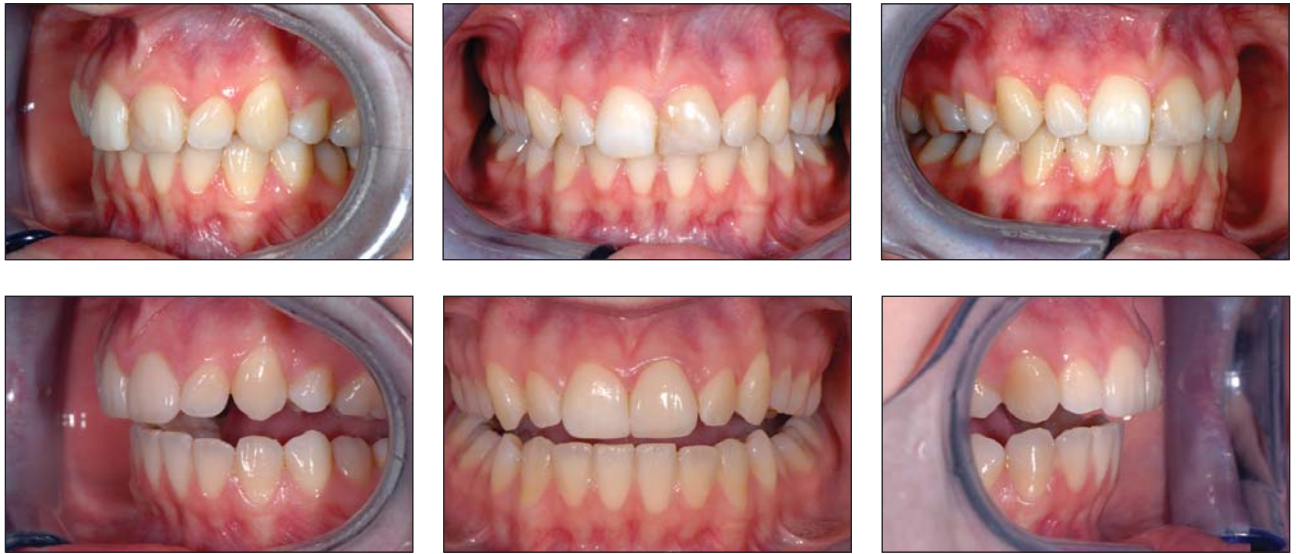
Figure 2: a-f – Retracted: *Before (above) and after (below) images of the case*

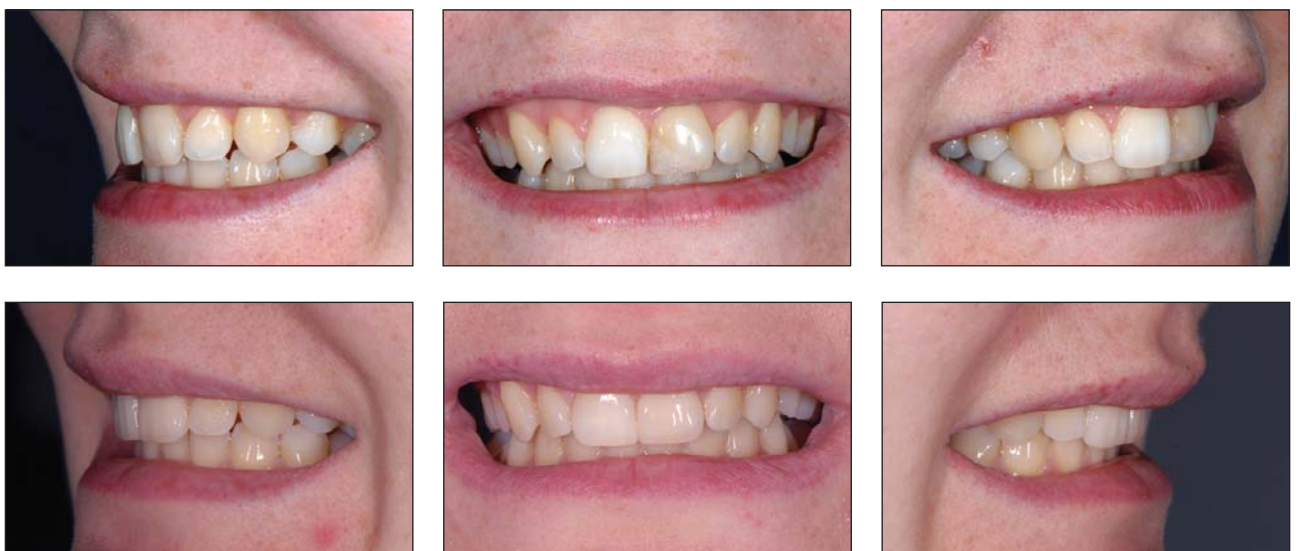
Figure 3: a-f – Smile: *Before (above) and after (below) images of the case*

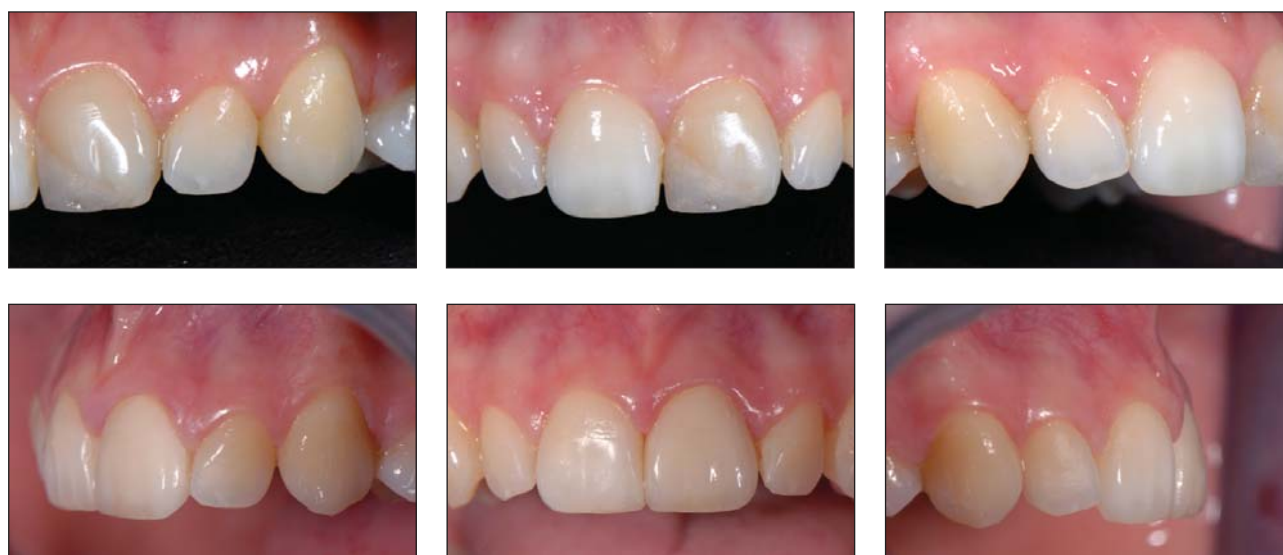
Figure 5: a-f – Anterior: Before (above) and after (below) images of the case
