# Two veneers to restore worn central incisors

Accreditation Case Type 2

Richard Lee BDS

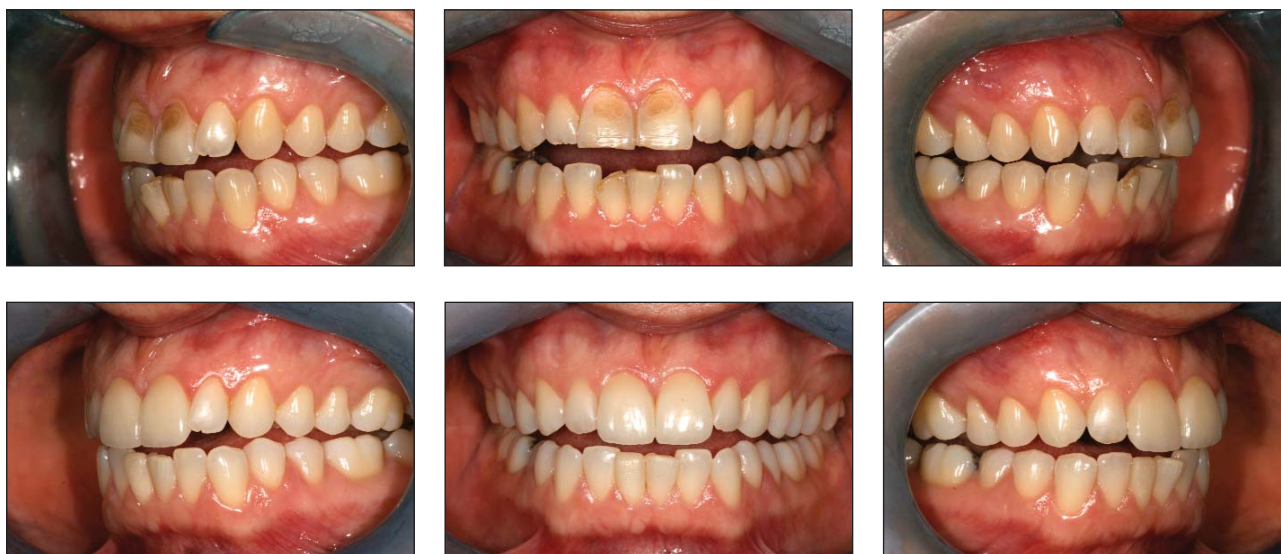
loss affecting the labial surface of her upper central incisors (11, 21) and superficial tooth fractures at 12 and 41. There was minor lower crowding present. Her periodontal condition was good with effective oral hygiene measures in place and her TMJs were healthy and classified as Piper stage 1.<sup>1</sup> Aesthetically, the overall colour of the teeth was relatively dark and the upper central incisors were severely worn with exposed dentine. The gingival heights of 11, 21 demonstrated asymmetry. Radiographically, all teeth were judged to be vital and the periradicular tissues intact.

The non-carious tooth surface loss affecting 11 and 21 appeared to be primarily erosive in origin. The labial, localised position of the lesions indicated that the causative factor was most likely dietary. Questioning revealed that heavy consumption fizzy drinks from a wide bore bottle – the diameter of which was approximately the width of two

central incisors – with the fluid being ‘drawn through the front teeth’ had occurred historically. The erosive nature of this carbonated cola drink had completely removed the labial enamel in the cervical third of the tooth; the exposed dentine was now becoming stained and noticeable to the patient.

Figure 1a: a-f – Retracted: Before (above) and after (below) images of the case

Following local anaesthetic administration the provisional restorations were removed and the tooth surfaces cleansed with pumice. The restorations were tried in to assess fit and overall colour. The ceramist at the same appointment then carried out final custom finishing and glazing. The teeth were isolated with rubber dam and the restorations bonded in place using a transparent veneer bonding cement. Care was taken to remove any excess resin from the margins and interproximally. The occlusion was checked and refined to provide equal multiple excursive pathways.

The patient returned one week later to have the occlusion checked and the final clinical photographs taken. She was delighted with the final result; a combination of minimally invasive veneers, composite bonding and whitening had transformed her appearance and allowed her to smile fully once again.

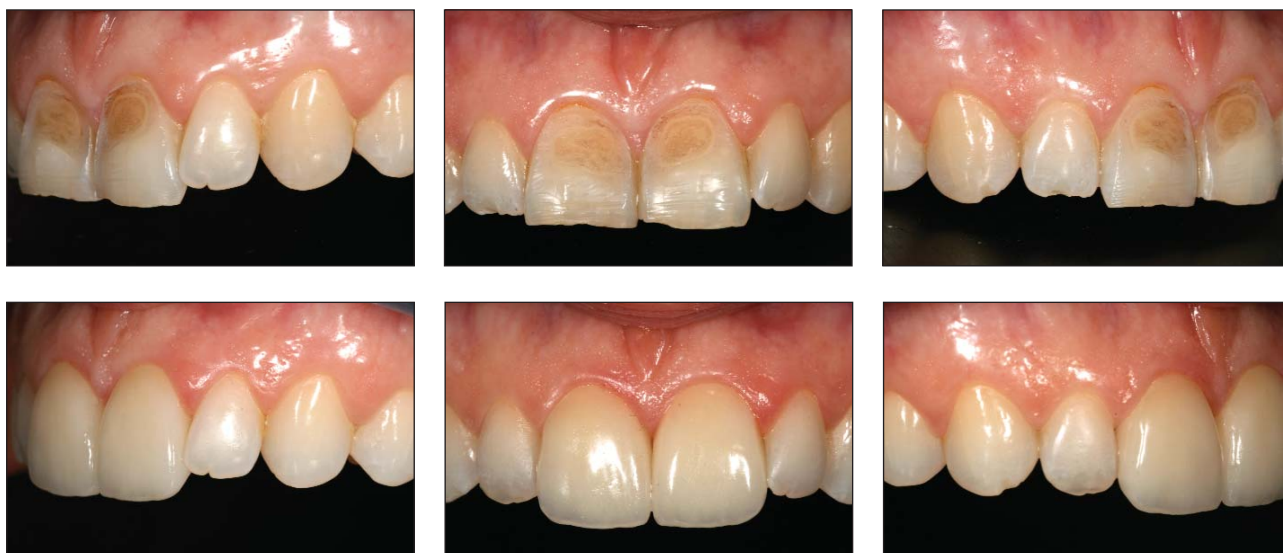
Figure 1c: a-f – Before (above) and after (below) images of the case

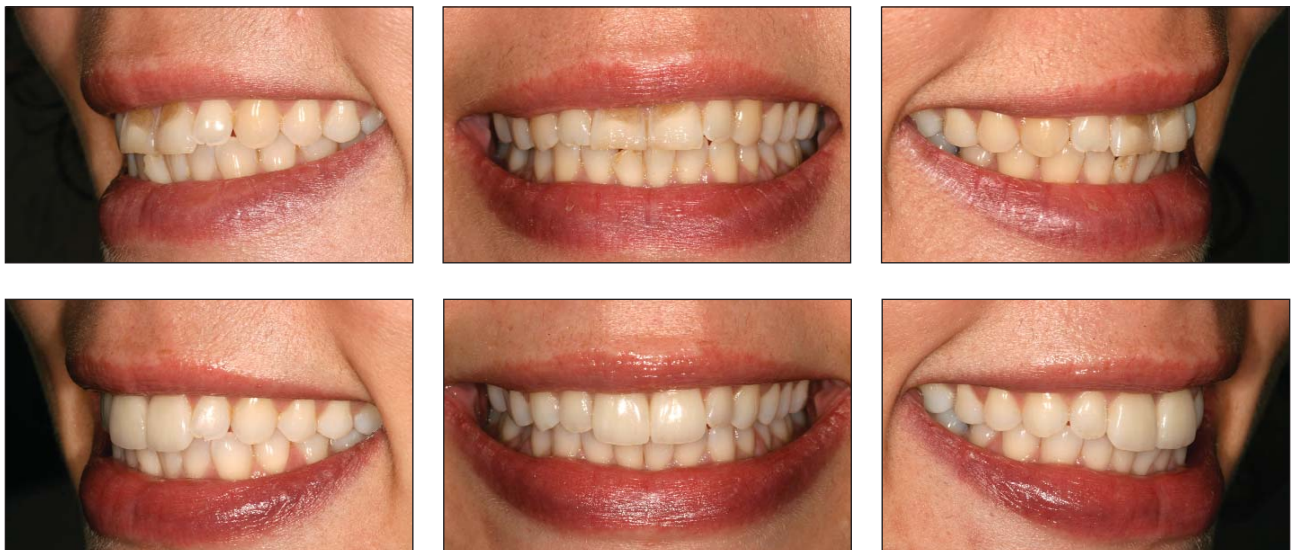
Figure 1d: a-f – Smile: Before (above) and after (below) images of the case
