# BACD Foundation Dentist Case Presentation Award 2020

Entry 1

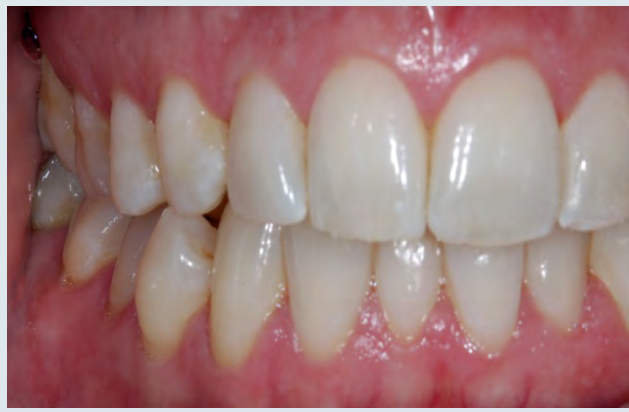
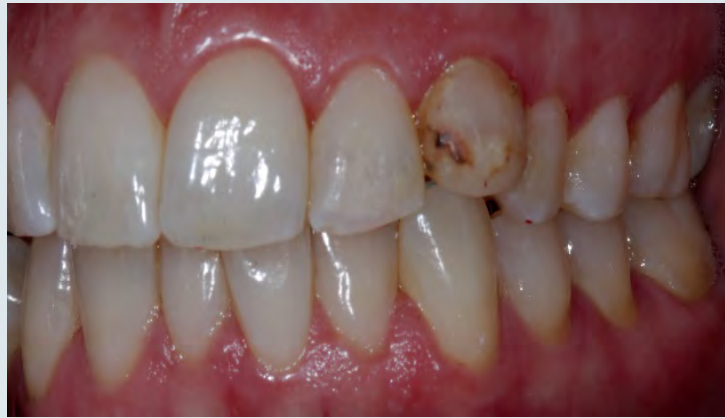
Figure 2.

Clinical characteristics	ULC
<b>Marginal adaptation:</b>	- Poor marginal adaptation to tooth surface, with roughness attracting plaque
<b>Anatomical form:</b>	- Zenith of ULC higher and broader than UR4 - Tooth torqued buccally, appears to protrude - LL3 tip quite prominent and little misaligned
<b>Marginal staining:</b>	- See figure 3
<b>Occlusal assessment:</b>	- Statically out of occlusion, with Left lateral excursion group function (4's and 5's)
<b>Lustre:</b>	- Loss of surface lustre, dull appearance of composite
<b>Secondary caries:</b>	- Nil

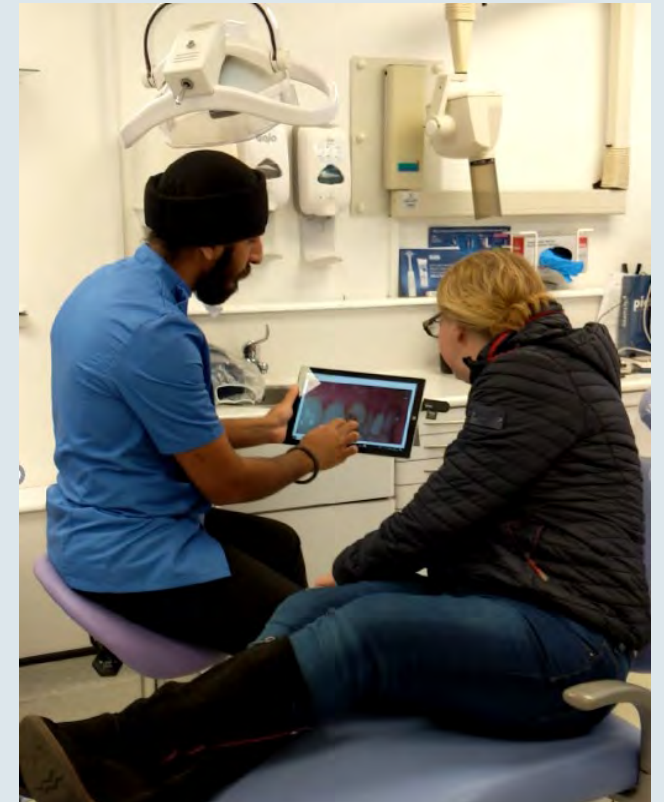
**Fig 4.**

Communicating management options and assessing patient expectations using photographs from DSLR transferred to a tablet

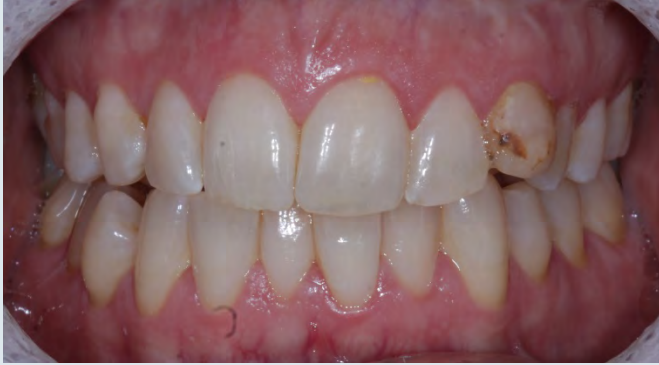
**Fig 5.1**

Pre-op photo. The patients main complaint was the aesthetics of the ULC

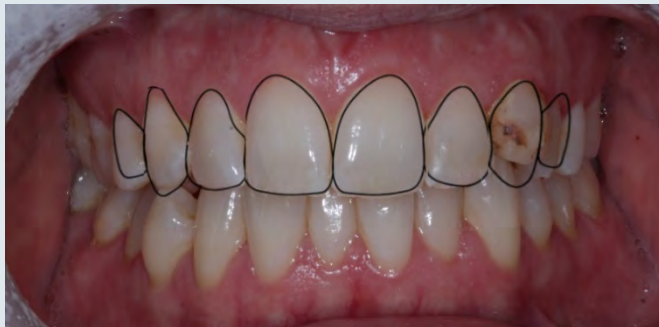
**Fig 5.2**

Digitally overlaying smile design template to plan the changes to achieve an aesthetic smile. Ideally canine tip lower, with reduced disto-buccal surface.

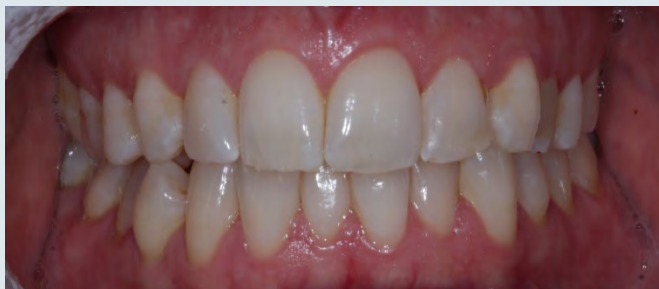
**Fig 5.3**

Digital mock up of aesthetic smile, mimicking the buccal surface of the opposing tooth

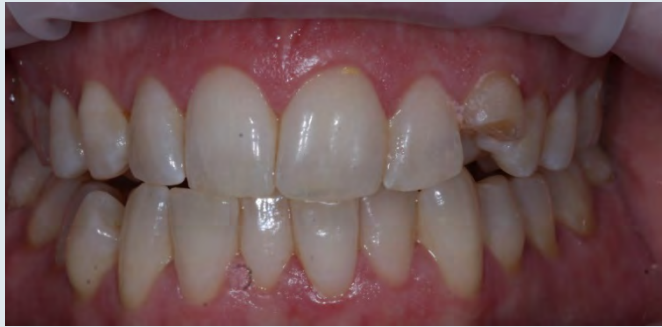
**Fig 5.4**

Existing failing composite removed using a fast hand piece, using a UV light torch (395nm wavelength). Biofilm removed with oil free prophy paste and polishing brush

As a first step the old composite restoration was removed, revealing its natural shape. To allow for maximising biological preservation a UV light torch (395nm wavelength) was used to assist with removal of composite. The biofilm from the ULC was removed using oil free prophylaxis paste and a rubber cup to prepare the tooth prior to restorative placement. A slight bevel was introduced to the margins of the restoration with a diamond bur and fast handpiece. The tooth surface was etched with 37% Phosphoric acid and bonding with 3M™ Scotchbond™ Universal Adhesive was used to increase the bonding forces in the enamel.

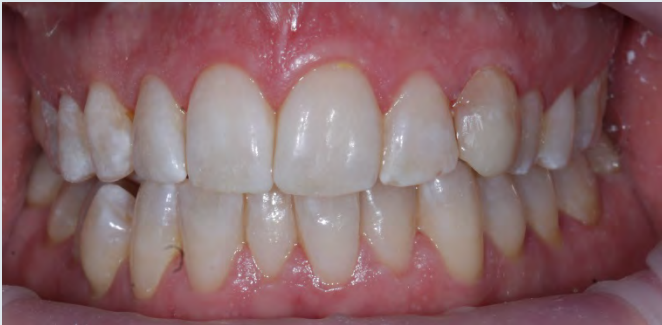
**Fig 5.5**

Composite build up using Ceram.x Spectra™ ST composites A2 and D1. Sectional matrix bands used to build mesial, distal and palatal wall. Free-hand build up, layered technique.

2 posterior sectional matrix bands were used vertically in the gingival sulcus to provide a guide to build the mesial and distal wall; with wooden wedges interdentally to stabilise the matrixes and improve the contour of the tooth. 0.5mm composite was used to build up the mesial and distal wall, followed by placing the sectional matrix horizontally palatally to build up the palatal wall.

The shell provided an outline of the rough outline of the final height of the restoration. The tooth was filled with D2 composite followed by a final layer of A1 composite. The matrixes were removed and final shape was refined with an extra fine (yellow) diamond bur. The final restoration immediately improved the patient's smile.

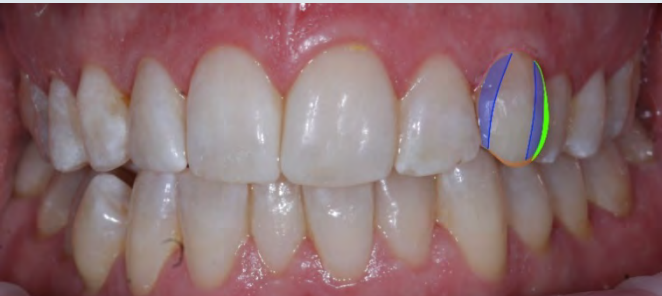
**Fig 5.6**

Adjustments planned for finishing and polishing

The Patient attended for a second appointment 2 weeks later to complete finishing and polishing; during which I had time to look at the current status of the restoration and plan changes to introduce further symmetry and improve aesthetics. The finishing was carried out with fine and extra fine finishing burs, in addition to red, orange, yellow and white polishing discs with polishing paste. See figure 6.

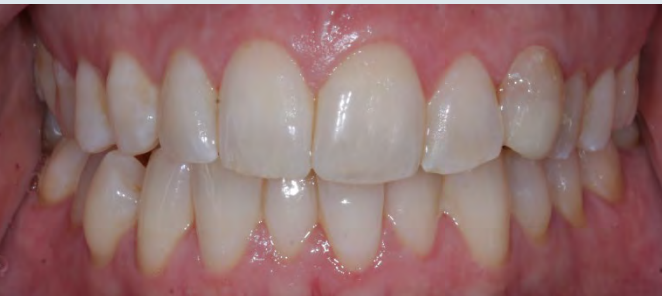
**Fig 5.7**

Post-op photo.

Immediately taken after finishing and polishing.

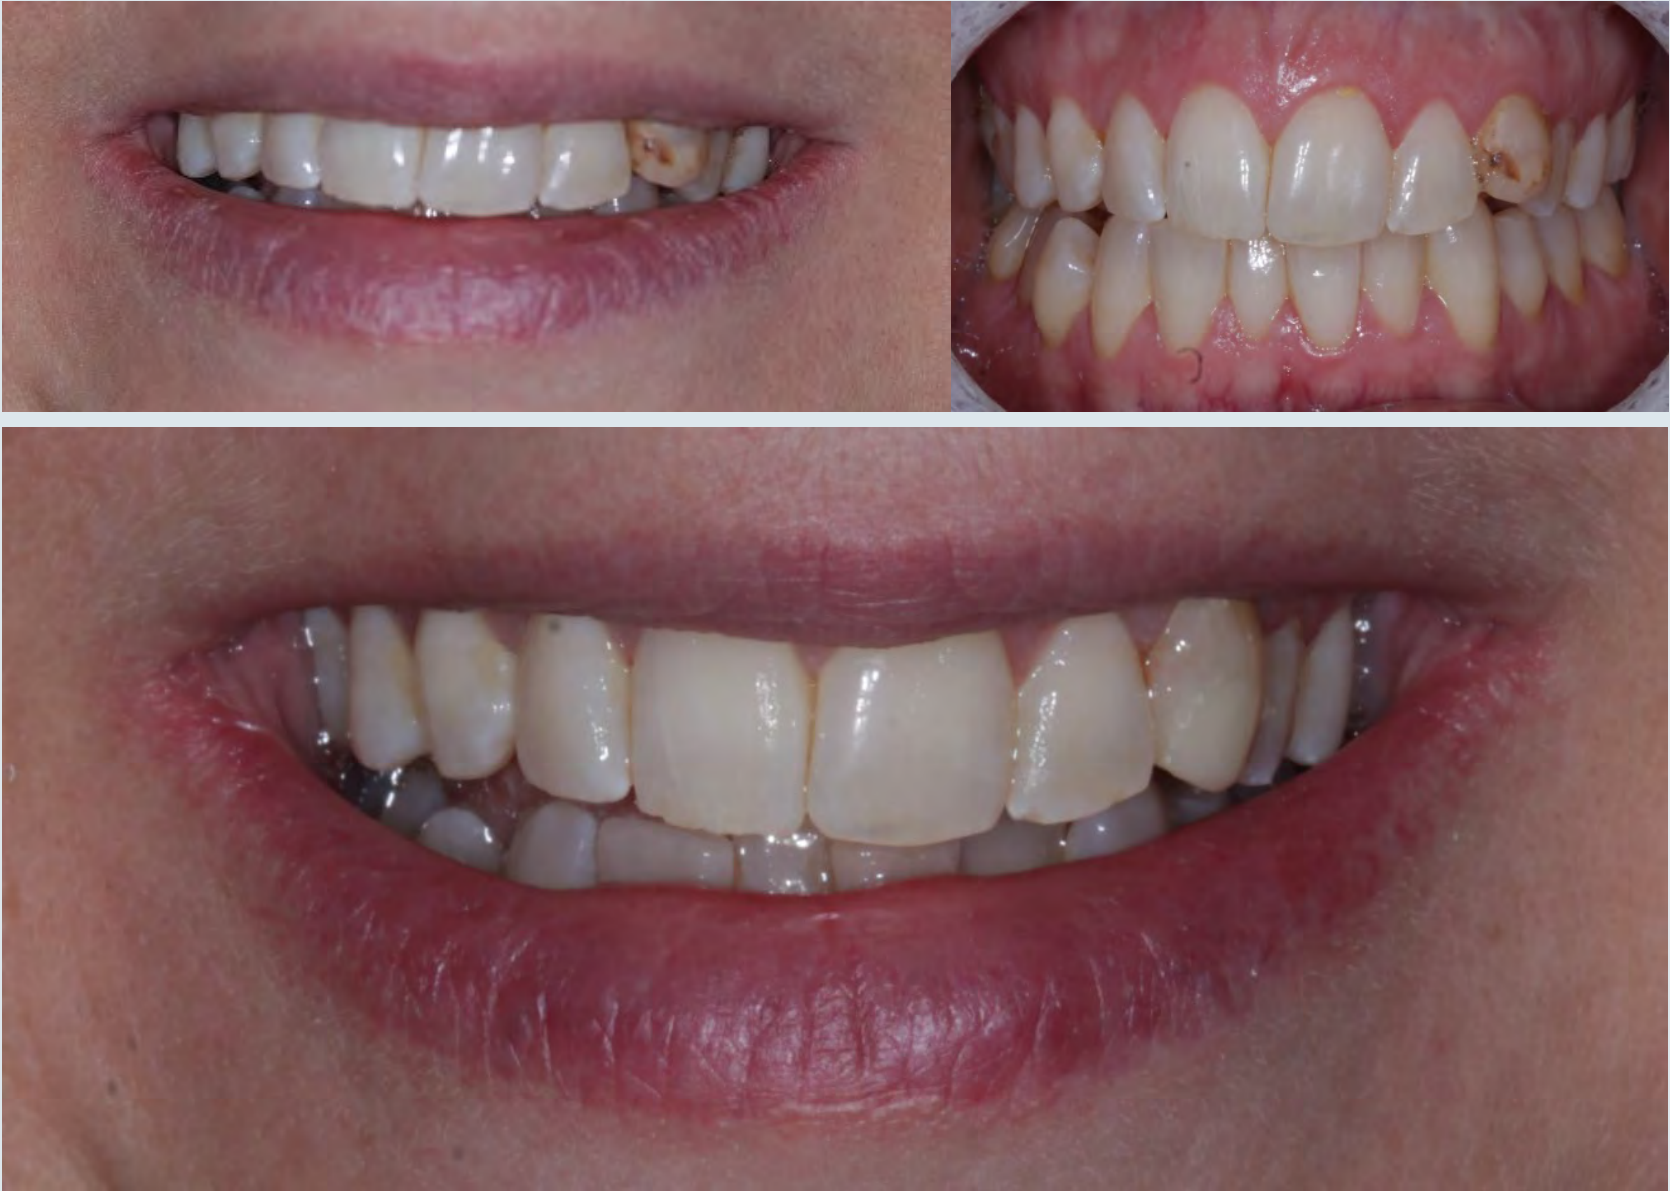
Figure 6. (Before and after – Smile)

- On reflection, the mesio-buccal portion of the tooth exhibits some darkness. This is either a result of the incomplete removal of the discoloured portion of composite or a result of discolouration from localised bleeding/gingival crevicular fluid from the gingival sulcus after removal of the sectional matrix. Whilst building the mesial and distal shell initially, there was a lack of bond between the shell and tooth which led to the shell being displaced from the tooth, hence requiring the sectional matrix to be replaced leading to localised bleeding from the sulcus. Ideally this would have been controlled by using a rubber dam inverted around the anterior teeth with floss ties apically to provide a more effective isolation around the tooth.

- There is a colour difference between the tooth and restoration which can be attributed to dehydration during treatment, which would resolve upon hydration. Secondly, this can also be a result of an incorrect colour match to the tooth itself which is darker in comparison to the anterior teeth. To enhance the aesthetics, I could speak to the patient about teeth whitening to improve the colour match of the tooth to the adjacent teeth. Alternatively, this could be a result of trying to prevent the restoration looking bulky hence maintaining a thin buccal profile leading to poor transition surface. This can be addressed at the review appointment\* by placing a thin layer of enamel composite on the buccal surface to allow for a more homogenous colour match.

- During the finishing and polishing appointment, I was able to add a thin layer of composite to mask the small area of darkness, this improved aesthetics immediately.
